Science and development - IR study for GPR Quality Control

Comparison of Asphalt Pavement spreading technologies
and quality control of thermography
the applicability of the study

Following is summary from the research project "Comparison of Asphalt Pavement spreading technologies and quality control of thermography" made by the Road Administration in Estonia 2014.

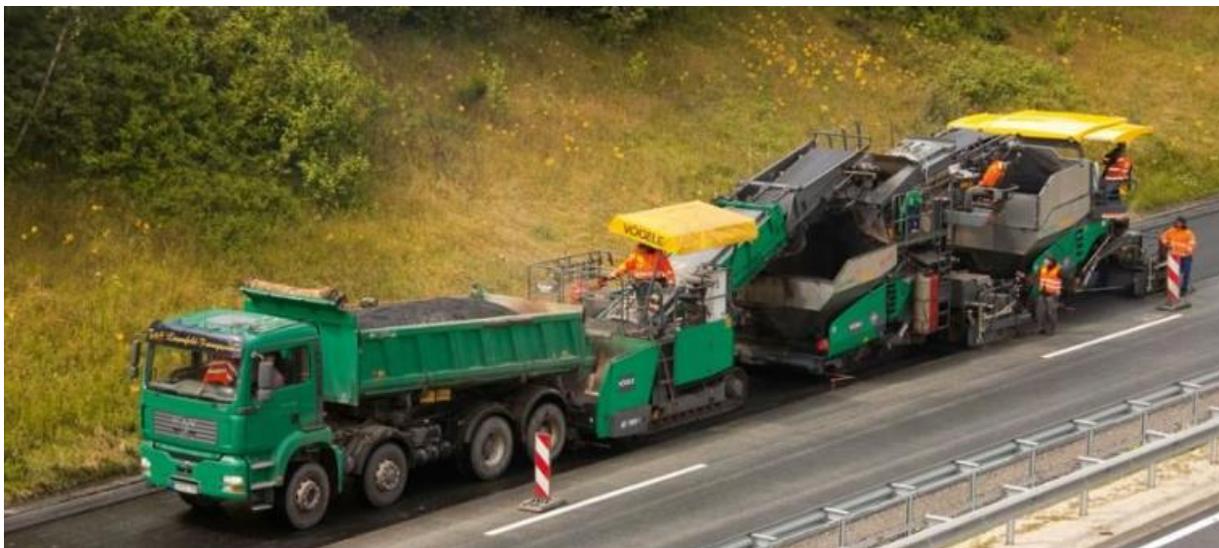
Figure - 1 and 2 Voegel "feeder" - asphalt spreader feeders workflow

One of these technologies investigated was asphalt feeder. We compared the road section paved with and without feeder. Also different asphalt plants were used, the transport distance and the other conditions were comparable. The study showed that the feeders **enable** significantly reduce segregation the asphalt. In this site no deductions were applied to contractor from air void measurements based on coresamples and we believe it is likely that there's no need for major repairs during the warranty period. Therefore, the only benefit from using feeders arise from reduction of downtime and hauling cycle speed - up, which alone obviously does not compensate for additional costs. Feeder, having roughly the price of paver, is worthwhile to be implemented only if the quality requirements from the customer are high enough and other, more effective options to ensure the quality are utilized. Unfortunately, so far these options have gained only very limited attention during the hauling and paving process-because the **motivation system is not effective enough**.

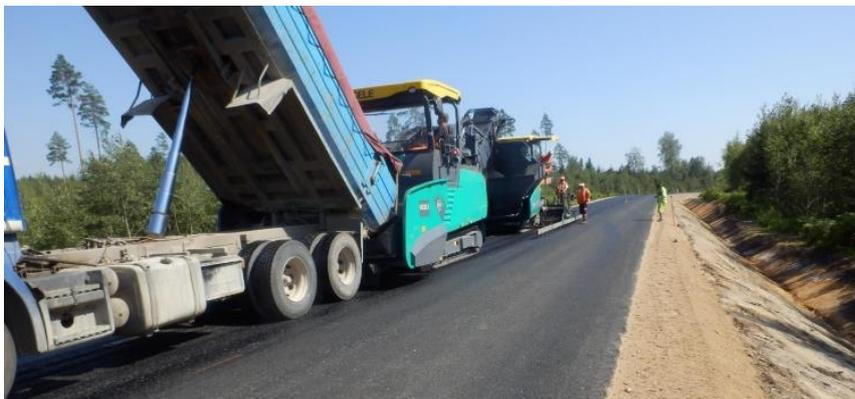
Figure – 2 Voegel "feeder"

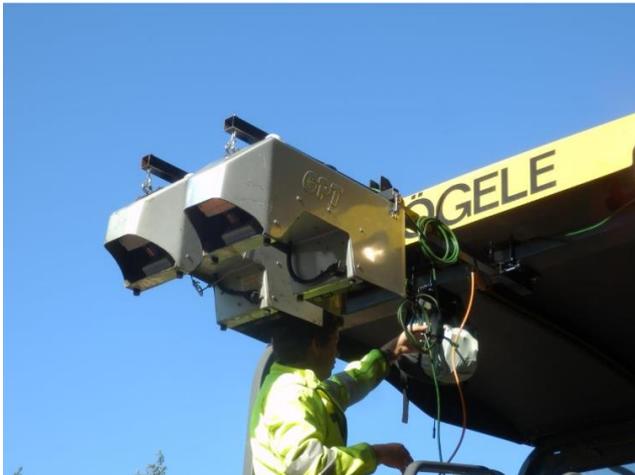
Figure 3- Thermo scanners, type GPX 34

The other technology is infrared thermal scanning based motivation system, developed and successfully used in Sweden. The system scans the hot pavement temperature continuously during the installation and as a result, work quality (100% coverage of paved area) can be easily evaluated in real time and respond to the problems immediately.

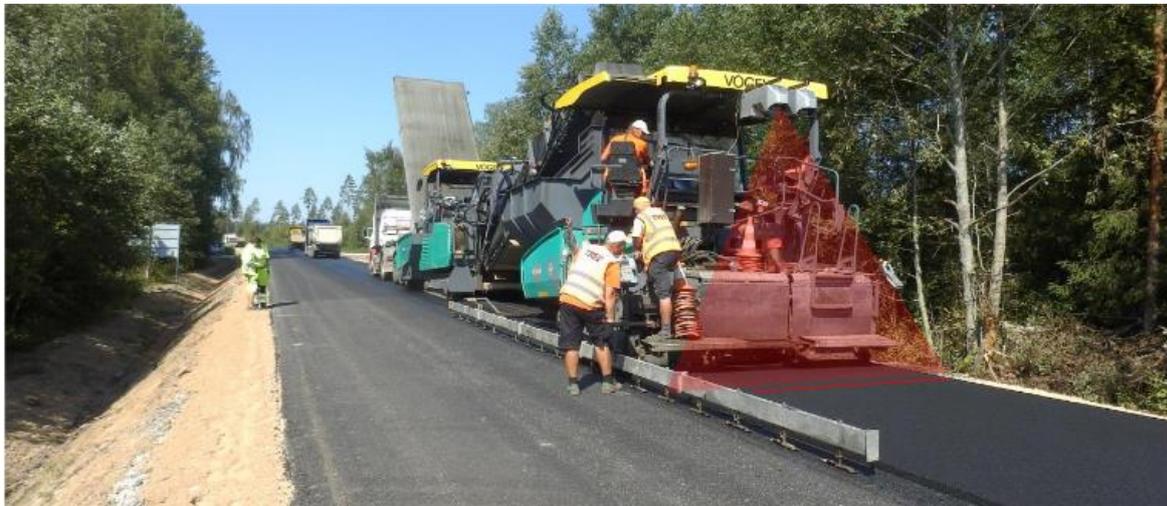
Figure 4 The thermo scanners covers the whole cross section of paved area

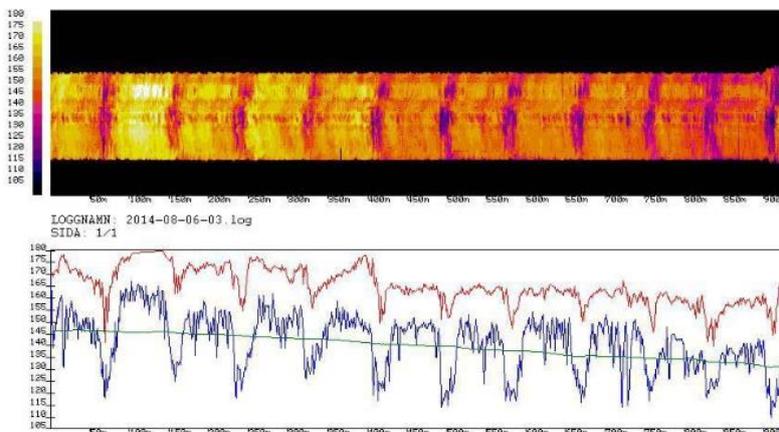
Picture from thermo scanner. Regular cool fields reflects the shift of asphalt trucks feeding the paver.

On the graph are shown the minimum and maximum temperature in each cross section of paved area.

Figure 5 - Thermo scanner results, paved without feeder.

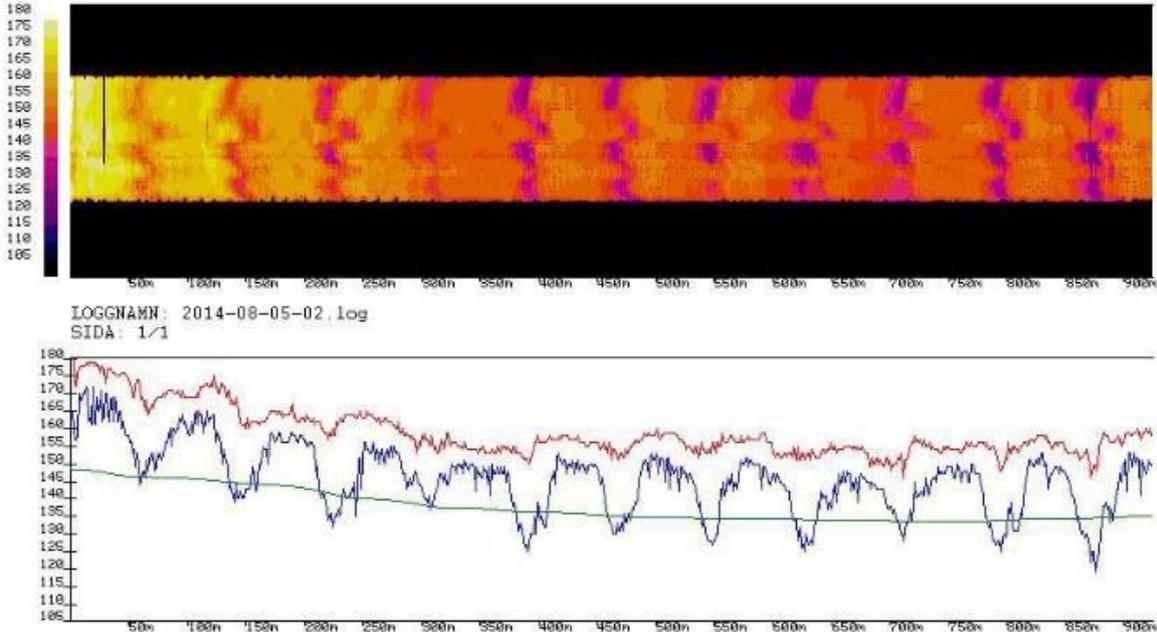
Figure 6 - Thermo scanner results, paved with feeder.

The idea of the green line (related to 30 min average) is to establish the basis for determining the risk area. This is local so-called cold spot which, due to significantly colder temperature has lower potential for compacting with the same effort. This is called „**risk area**“.

Performance of pavement can significantly be improve if the risk area can be reduced – which mean less porous pots. **It is extremely important in climates with many freeze-thaw cycles in upper part of pavement.**

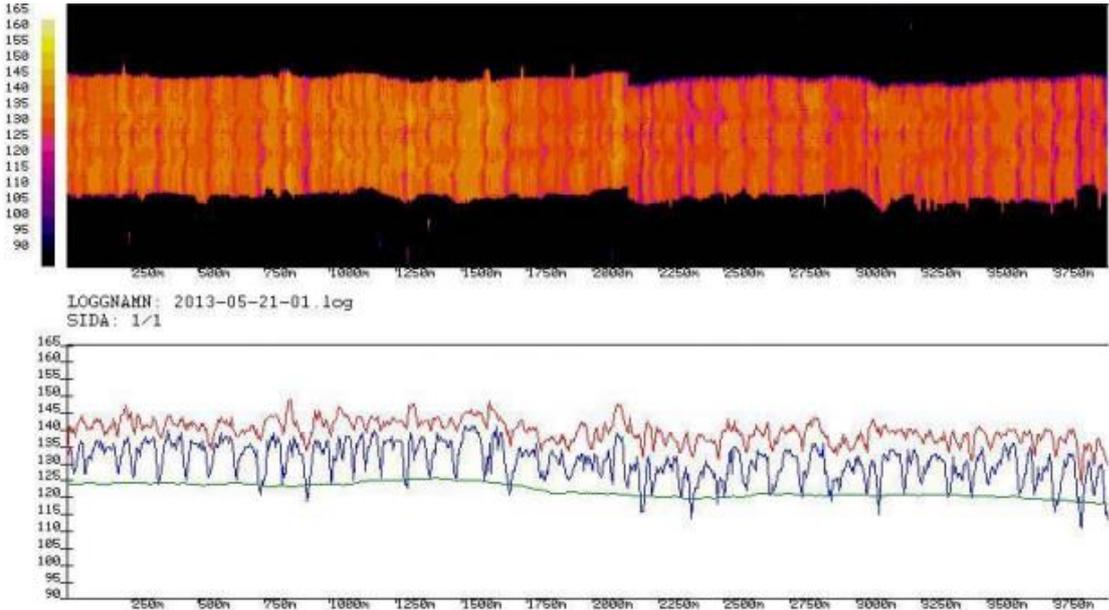
Figure 7 - Thermo scanner results from Sweden, asphalt loaded with trucks only and motivating bonus system.

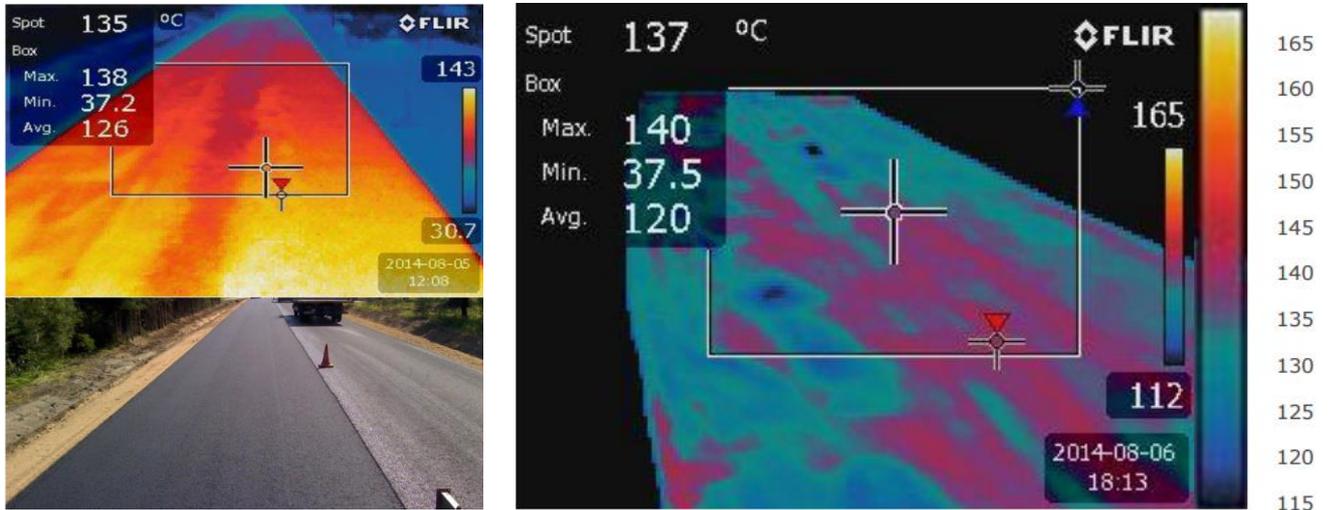
Figure 8 Examples showing temperature range using a handheld thermal camera.

Feasibility of using handheld infrared cameras was also evaluated in the study. It was found that despite the relatively low cost of such devices (about €1,000... 8,000 depending on the model), its use in the road works supervision process is relatively **costly** if properly done and can be even harmful if deployed poorly.

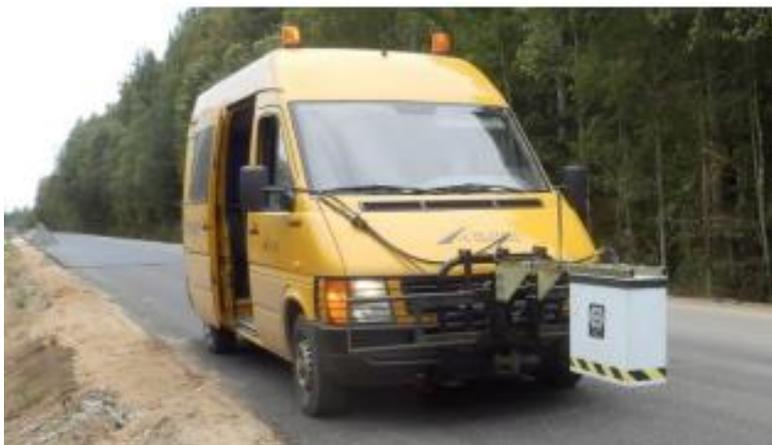
Figure - 10 Residual porosity investigation were carried out with GPR GSSs (1.2 GHz antenna)

Rather positive results were obtained from Ground Penetrating Radar (GPR) studies as continuously measured air void contents of pavement very well correlated with those of infrared thermal scanning. Thus making it a mandatory component of the motivation system for upper pavement layers would be **very effective and highly recommended**.

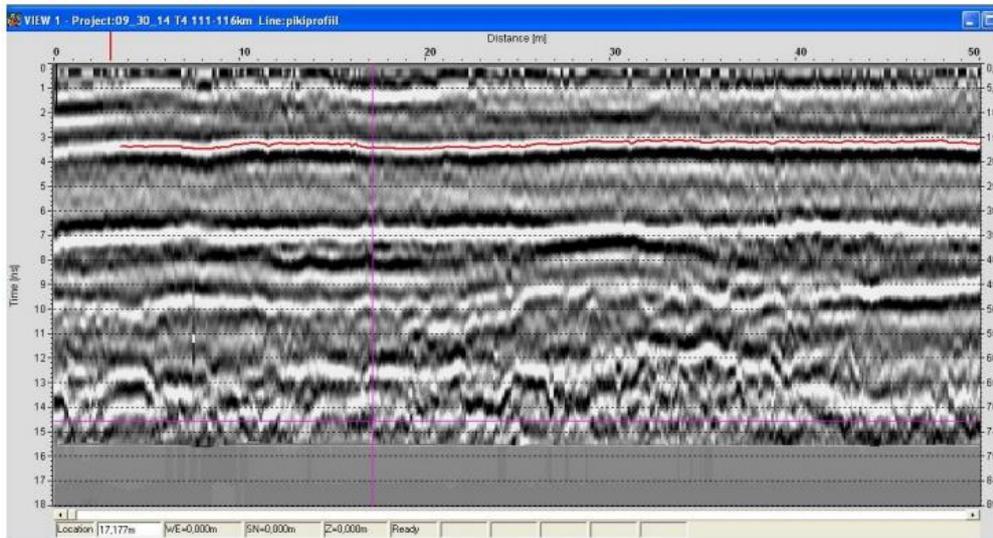
Figure 11- Layer thickness determination by GPR results.

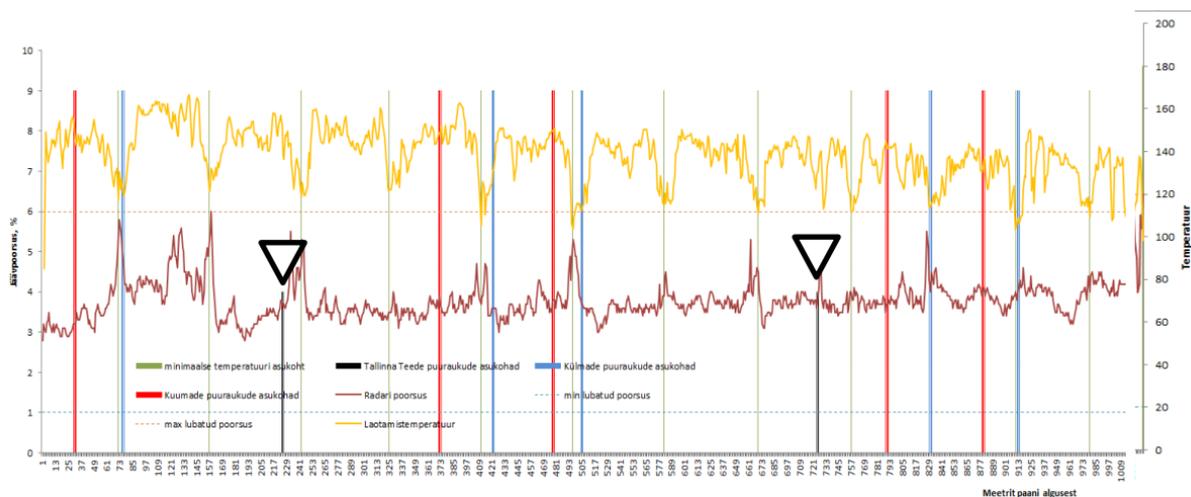
Figure 12 - Residual porosity and the installation of a temperature graph

As can be seen from the graph above, such air voids (red in graph) shows pretty good correlation with temperatures (in yellow) and the location of change in asphalt trucks. The State Highways in Estonia are working on both methods, thermal scanning primarily as a real-time tool for contractor and GPR primarily as a pavement quality control tool for client.

The GPR is also used to measure air voids in upper layer of asphalt which is based on the knowledge, that asphalt layer components like aggregate and binder have similar E_r (dielectric value) and the aggregate/binder ratio is quite constant while air voids have significantly lower E_r value and affects the overall E_r value as well. This E_r value is calculated from measured signal travel times and calibrated with real samples. This makes possible to get air void values virtually continuously and as can be see from the report.
