University of Washington

Civil Environmental Engineering

Paving Quality and Infrared Imaging

Joe Mahoney

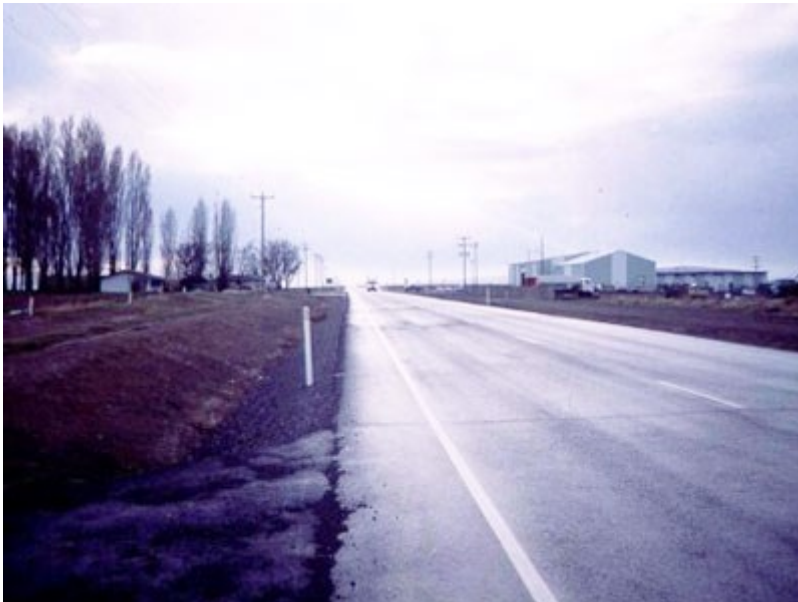
Cyclic Density: The pavement distress that occurs when low temperature HMA is compacted.

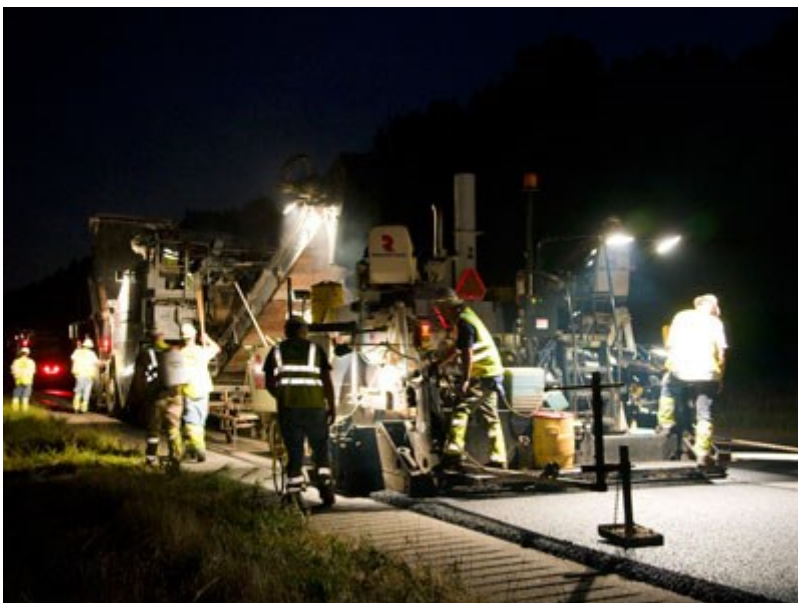
Night Paving: Paving at night can contribute to the cyclic density problem.

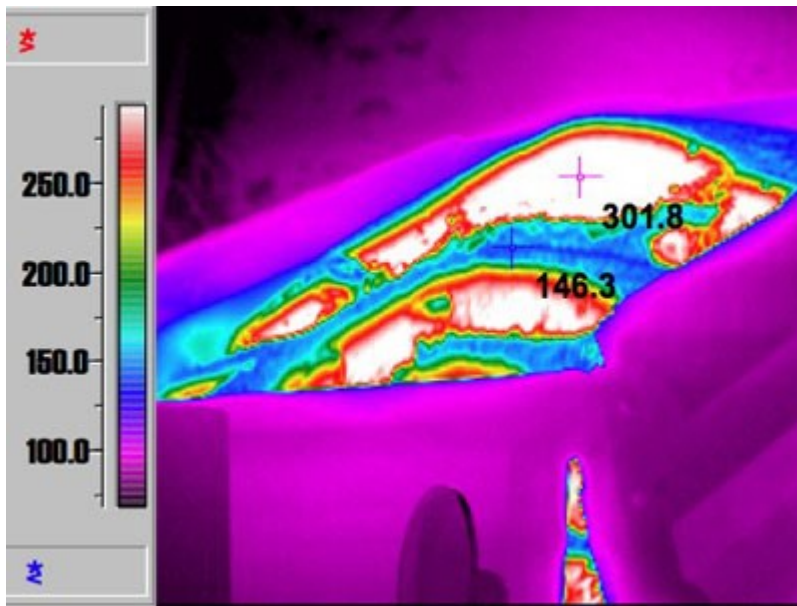
IR Truck Temperatures: The problem starts with cooling of the HMA in the truck in transit to the job site.

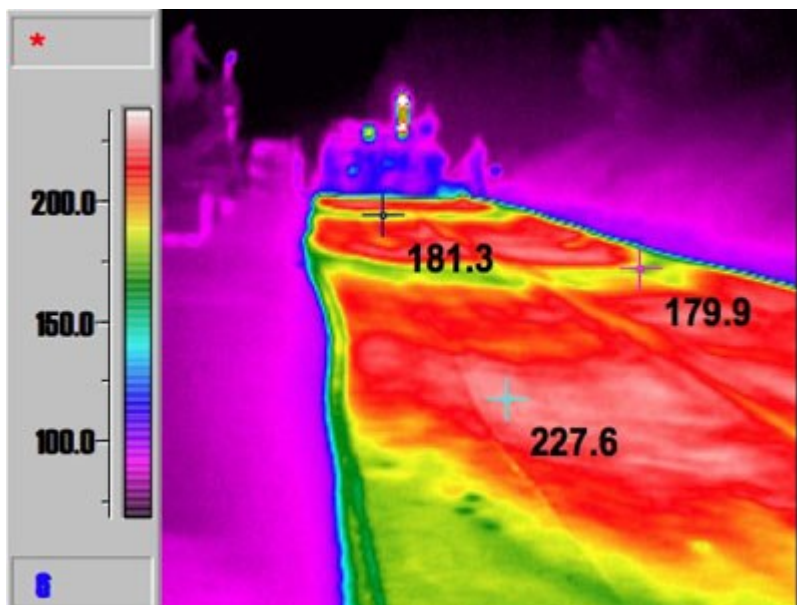
IR Paving Temperatures: An infrared image shows where the cooler (undesirable) mix is located behind a paving machine.

Two separate studies were performed that (1) identified the problem, and (2) quantified its severity, and (3) recommended changes to construction practices. Infrared imaging was used to survey projects under construction and this work was the first to use this technology in paving. Now, use of infrared imaging is commonly done through the US.
